The Chief Joseph Hatchery Program

Okanogon River Adult Fish Pilot Weir

2022 Summary of Methods & Results

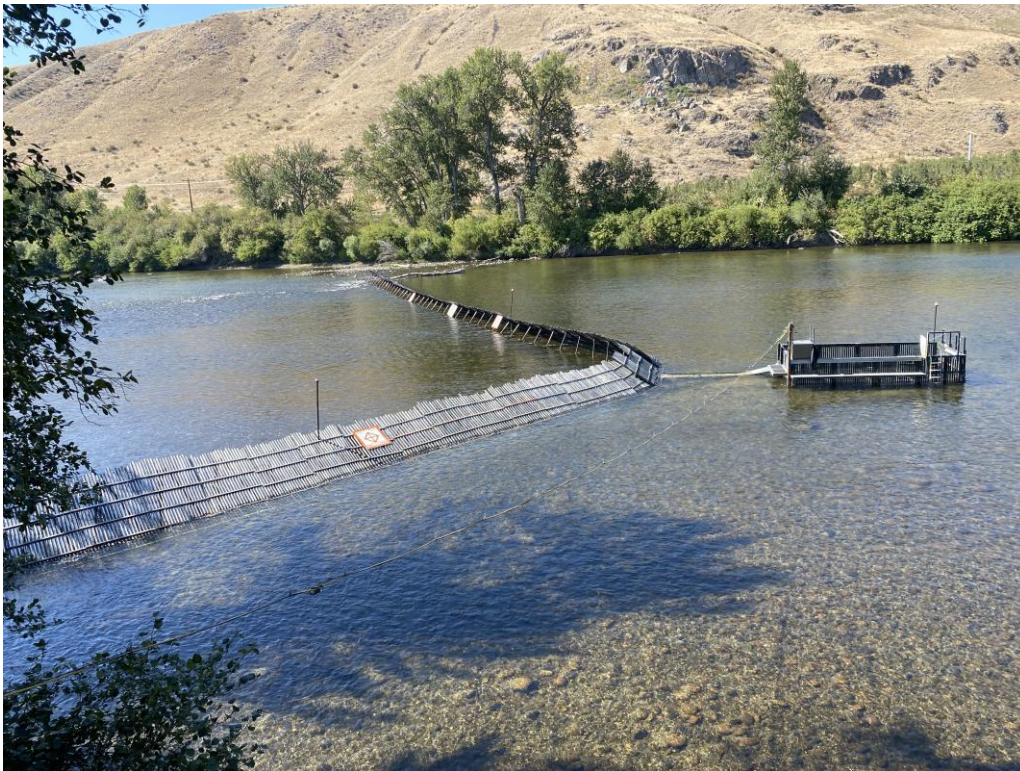
Figure 1. Lower Okanogan adult fish pilot weir, 2022. Photo taken in early September shortly after deployment.

The lower Okanogan fish weir was installed approximately 1.5 km downstream of Malott, WA (48°16’21.54 N; 119°43’31.98 W) in approximately the same location as previous years. Weir installation began on August 30th at a river flow of 1,080 cfs. and was completed with the underwater video system on September 8th. An aluminum trap was installed near the center of the channel at the downstream end of the deep pool in the thalweg of the channel. The trap was 3 m wide, 6 m long and 3 m high (Figure 1). A fifteen-foot aluminum accelerator chute was installed at the downstream trap gate. The wings of the weir stretched out from either side of the chute towards the riverbanks, angling downstream in a slight V configuration. The wings consisted of steel tripods with aluminum rails that supported the 3 m long Acrylonitrile butadiene styrene (ABS) pickets. Each panel was zip-tied to the adjacent panel for strength and stability. Gravel bags were placed between panels when needed to fill gaps that exceeded the target picket spacing. Picket spacings included 2.5 cm (1 inch) and 5.1 cm (2 inch) sizes (Figure 2). Pickets were manually forced into the river substrate upon deployment and then as needed to prevent fish passage under the weir.

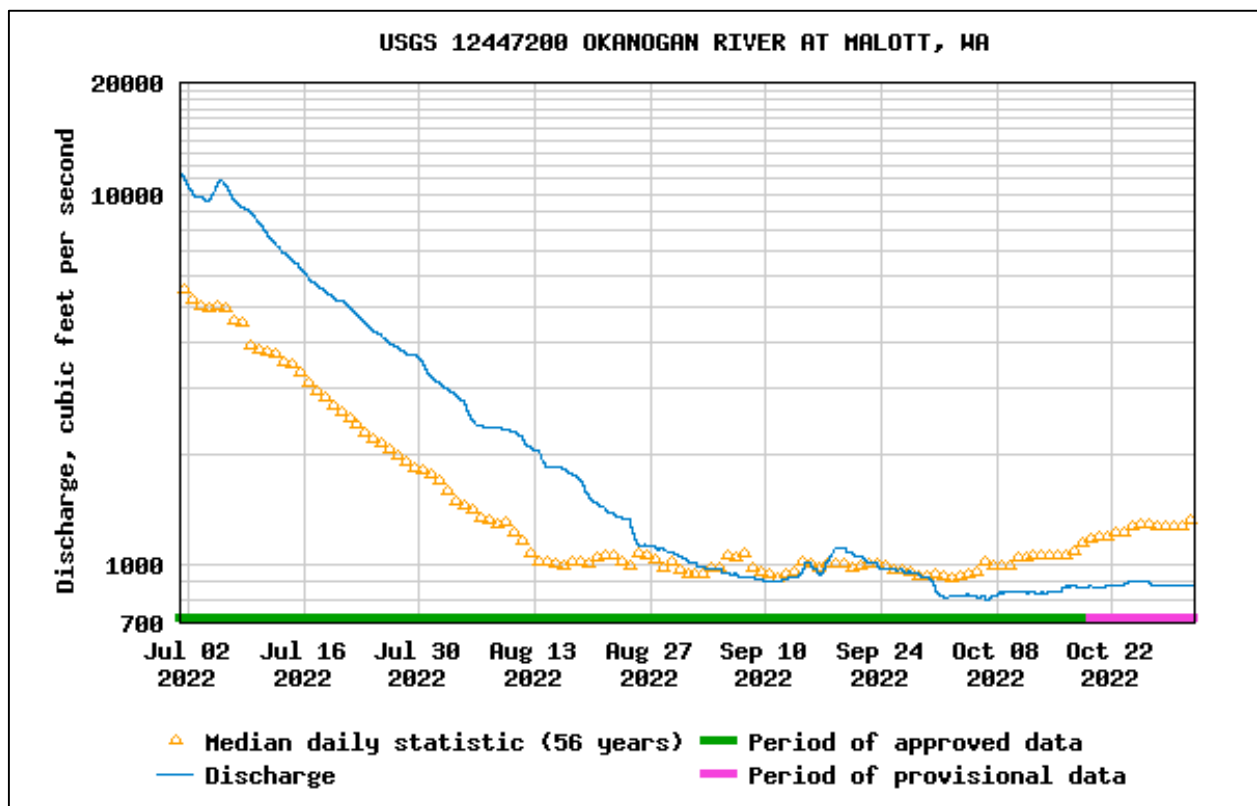
Figure 3. Discharge of the Okanogan River between July 1 and October 31, 2022. This figure was copied directly from the USGS website (<http://nwis.waterdata.usgs.gov/wa>).

The Okanogan River (at Malott) discharge was above normal in 2022 which delayed deployment of the weir till August 30th with the river flow at 1,040 cfs (Figure 3). Discharge continued to drop throughout the season and was approximately 942 cfs by the time the weir was removed for the season on September 28.

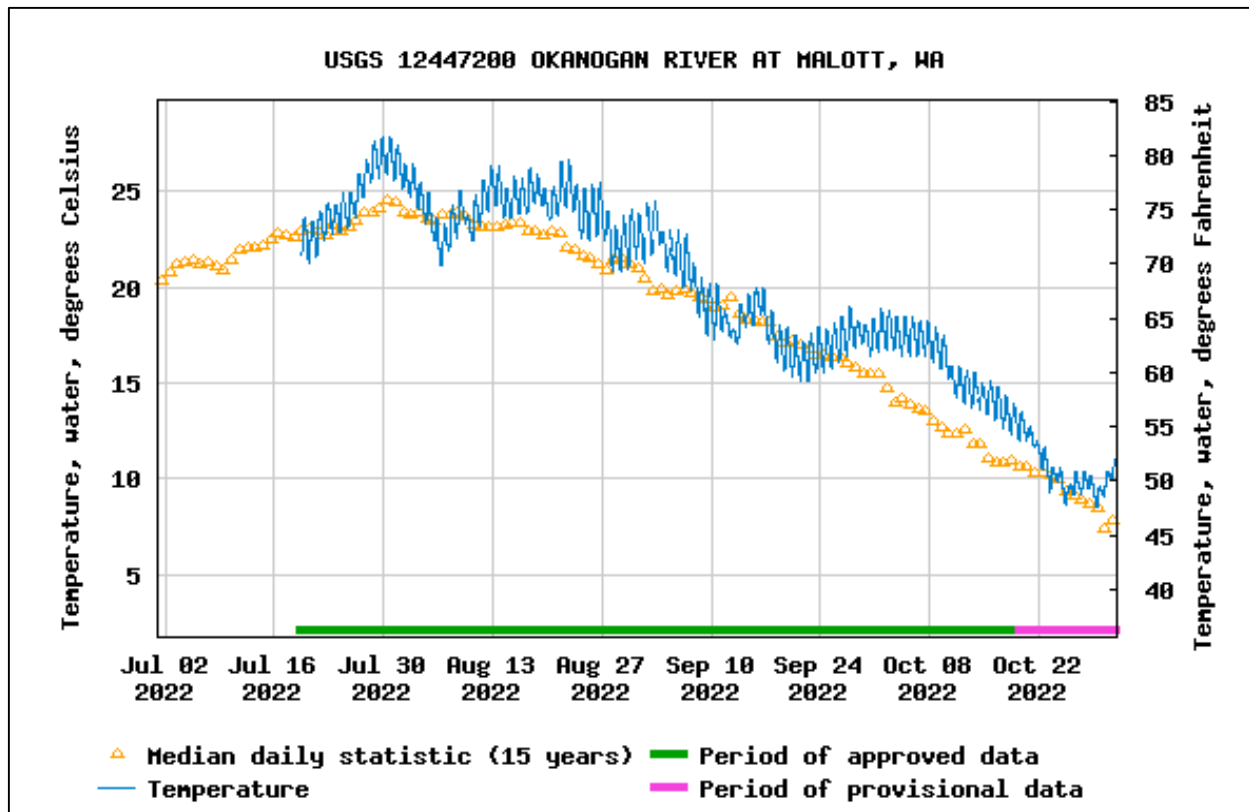
Figure 4. Temperature of the Okanogan River between July 1 and October 31, 2022. This figure was copied directly from the USGS website (<http://nwis.waterdata.usgs.gov/wa>).

Migration of sockeye and summer/fall Chinook is generally affected by a thermal barrier that is caused by warm water temperatures ($\geq \sim 22^\circ \text{C}$) in the lower Okanogan River. The thermal barrier is dynamic within and between years, but it generally sets up in

mid-July and breaks down in late August. In some years, the Okanogan River will temporarily cool off due to a combination of interrelated weather factors including rainstorms, cool weather, cloud cover and/or wildfire smoke. This 'break' in the thermal barrier can allow a portion of the fish holding in the Columbia River to enter the Okanogan and migrate up to thermal refuge in the Similkameen River or Lake Osoyoos. In 2022, temperatures were a little above the median daily temperatures from the last 15 years (Figure 4). Daily mean temperature was above 22.5 °C from July 1-August 27 and then dropped below it for a couple days before it went back above it from August 30- September 3. The temperature went back below the threshold on September 4 and stayed below for the rest of the season.

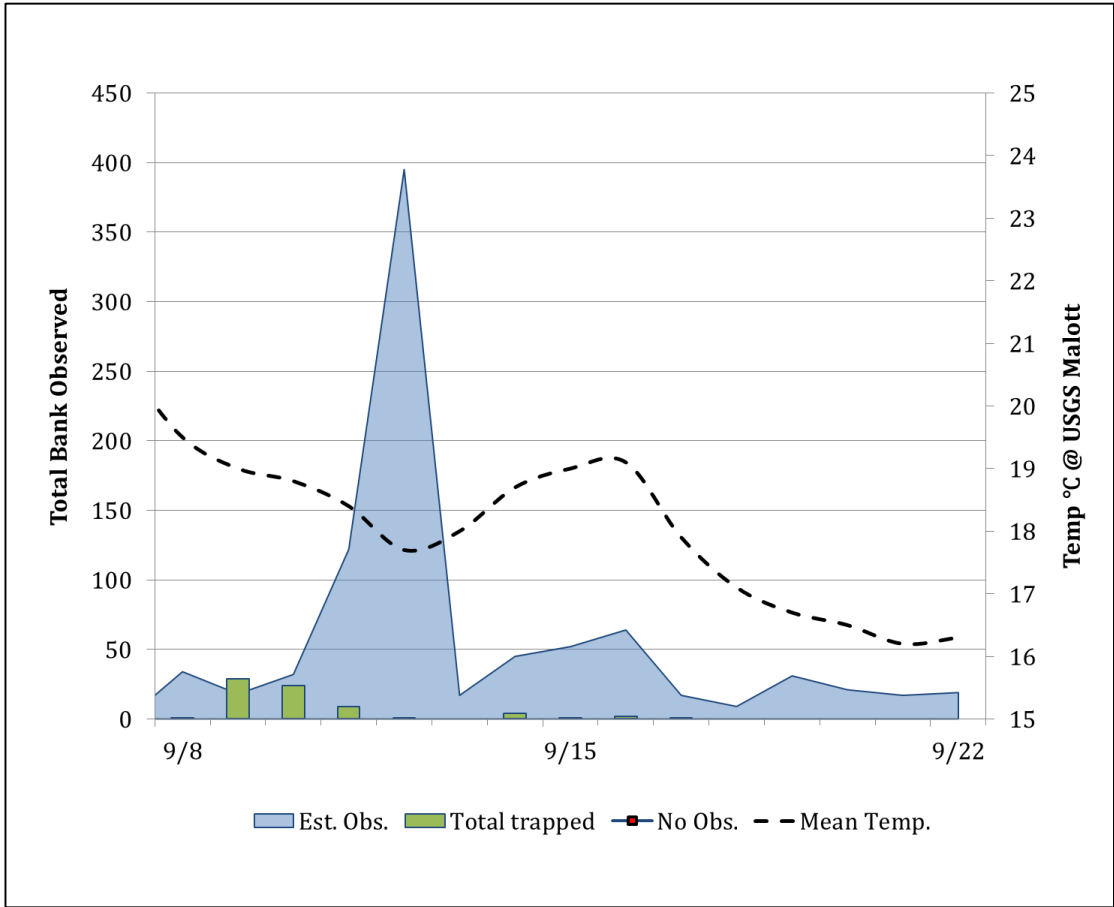
Figure 5. Estimate of Chinook observed from the bank at the lower pool, 0.8 km downstream of the weir.

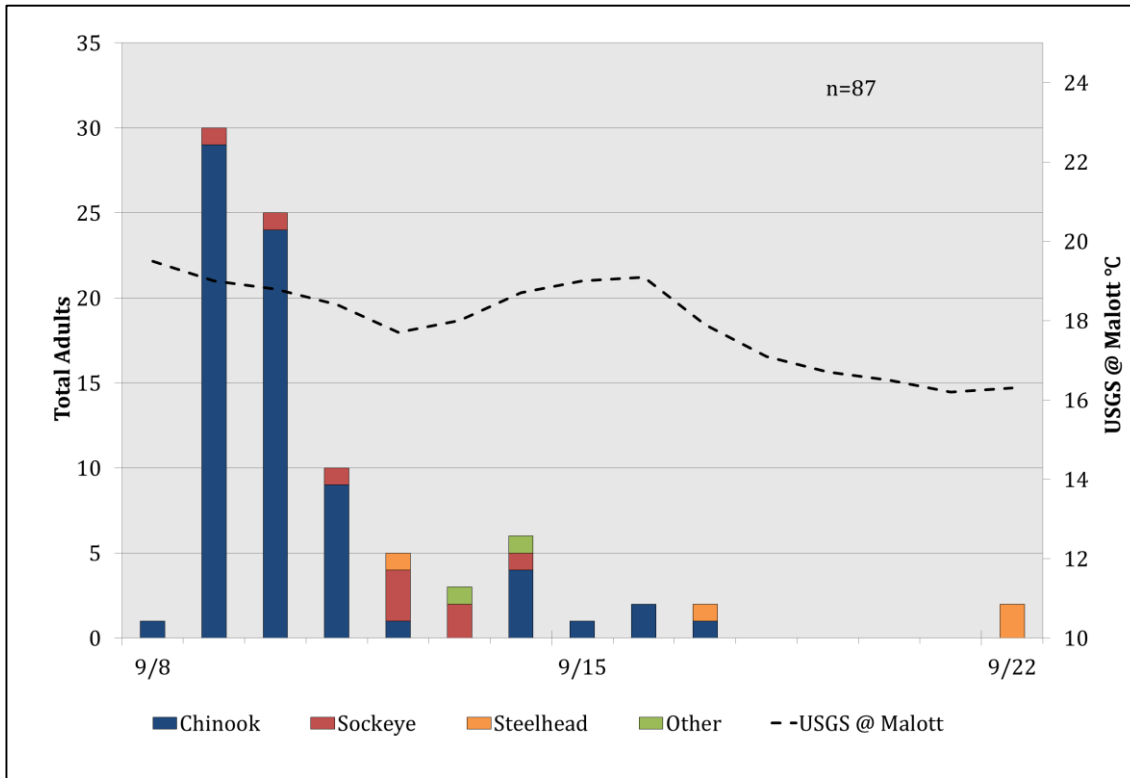
Figure 6. Total number of fish trapped at the Okanogan weir in 2022.
